1.0 INTRODUCTION

1.1 History of Griffy Lake Nature Preserve

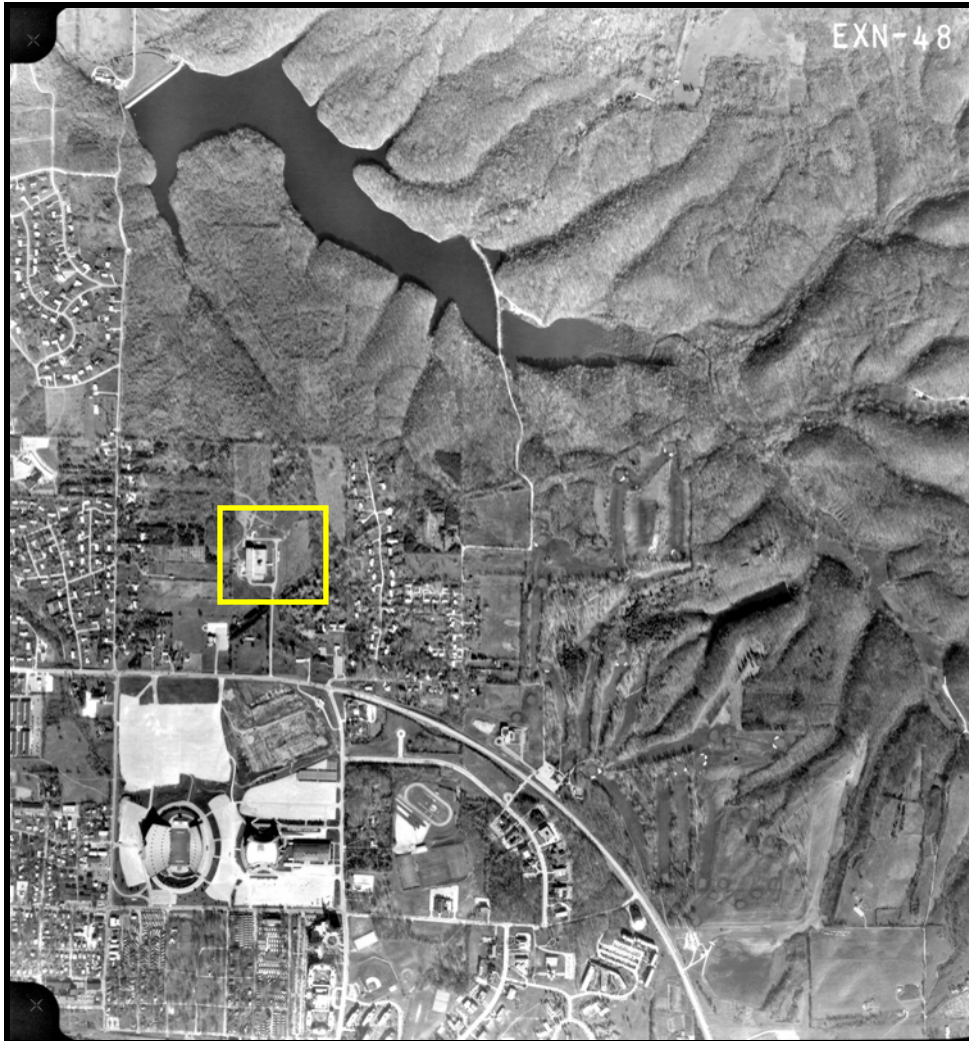
Figure 10. The Meadowood Retirement Community development represents the major land use change in the southern watershed since 1975. Source: 1975 aerial photograph.

Development in the Griffy Lake watershed can be better seen by comparing 1975 aerial photographs with the 2005 aerial coverage. (1975 aerials occurred closest in date to the 1984 master plan and are therefore being used for comparison purposes.) The Meadowood Retirement Community is the largest property that has been developed within Griffy Lake's watershed since 1975. The property is located immediately south of the Griffy Lake Nature Preserve (Figure 10). Additional expansion of this facility and Jill's House represent in-progress development within the watershed at the time of plan development. At the eastern edge of the watershed, a number of developments have occurred since 1975 and continue currently. These developments include Indiana University facilities along Range Road, expansion of Fountain Park, and construction of housing at Woodbridge, Tamarron, Devonshire, Rachel's Glen, and Timbercrest (Figure 11).

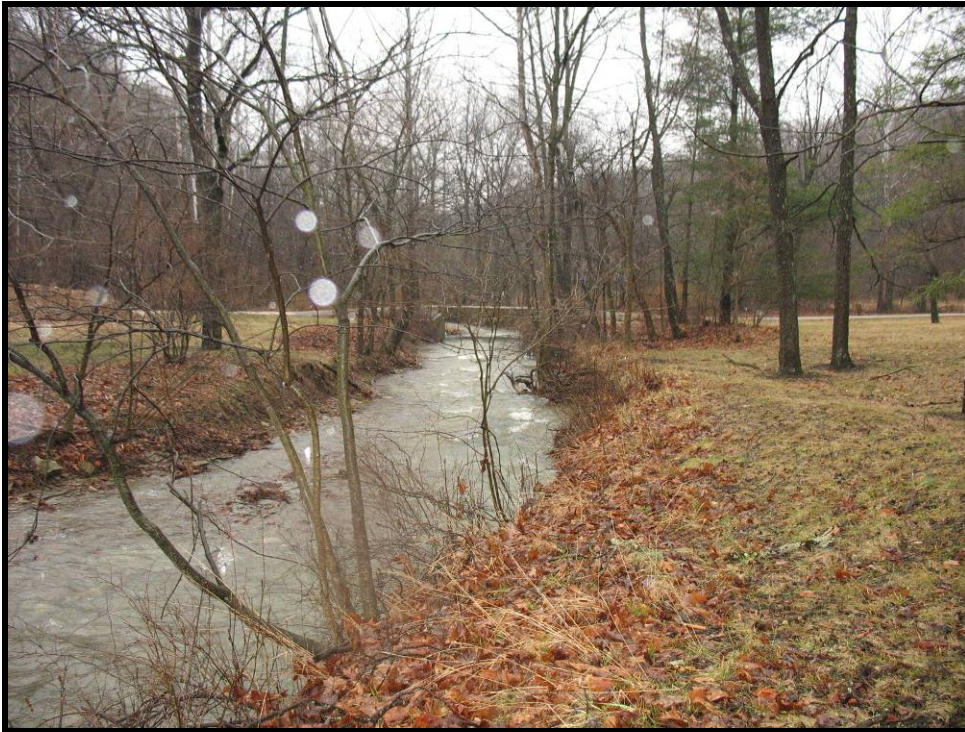
Figure 13. Streambed and bank erosion along Griffy Creek adjacent to Lanam Road.

Urban and suburban development replaces undisturbed land having higher water infiltration capacities with impervious surfaces (roofs, roads, parking lots, etc.) that allow no water infiltration. The result is an increase in runoff during storm events. The increased runoff may create erosion channels on the land and thereby increasing flow velocities of water in stream channels. The higher velocities contain more kinetic energy that erodes the bottom and sides of the existing stream channels. This eroded sediment, and nutrients and other materials, make their way down the channels to Griffy Lake. Representative problem areas related to streambed

and bank erosion are shown in Figures 13 and 14, while Figure 15 documents the impact of development within the watershed which results in reduced groundwater infiltration.

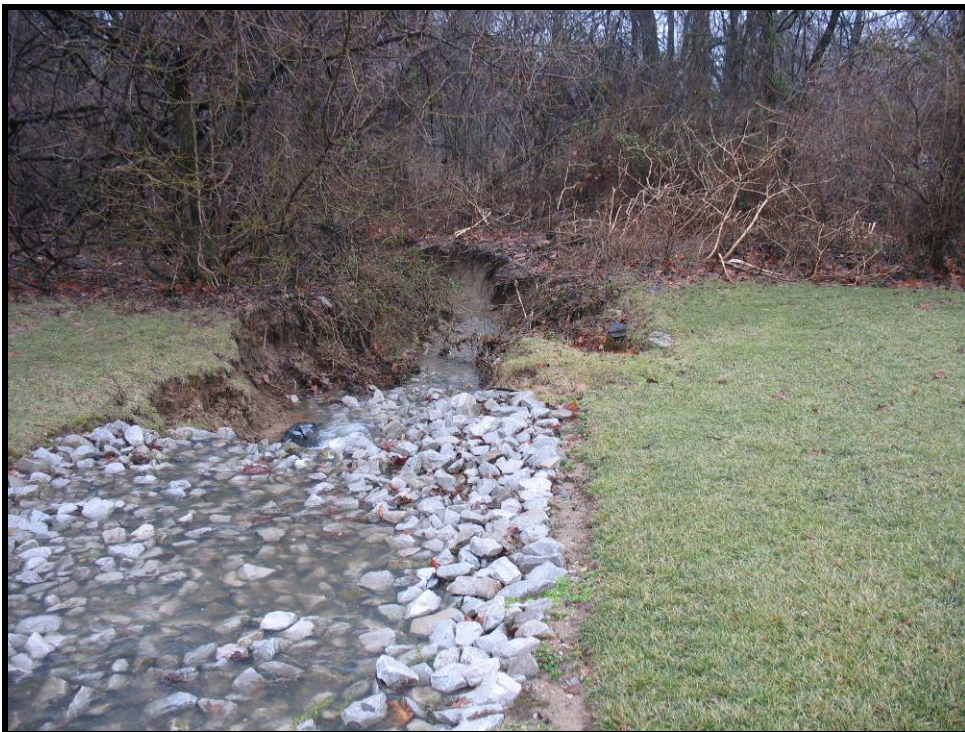
Figure 14. Runoff from the Indiana University (IU) Foundation drains via a rip-rap lined ditch but substantial erosion is apparent where the rip-rap ends.

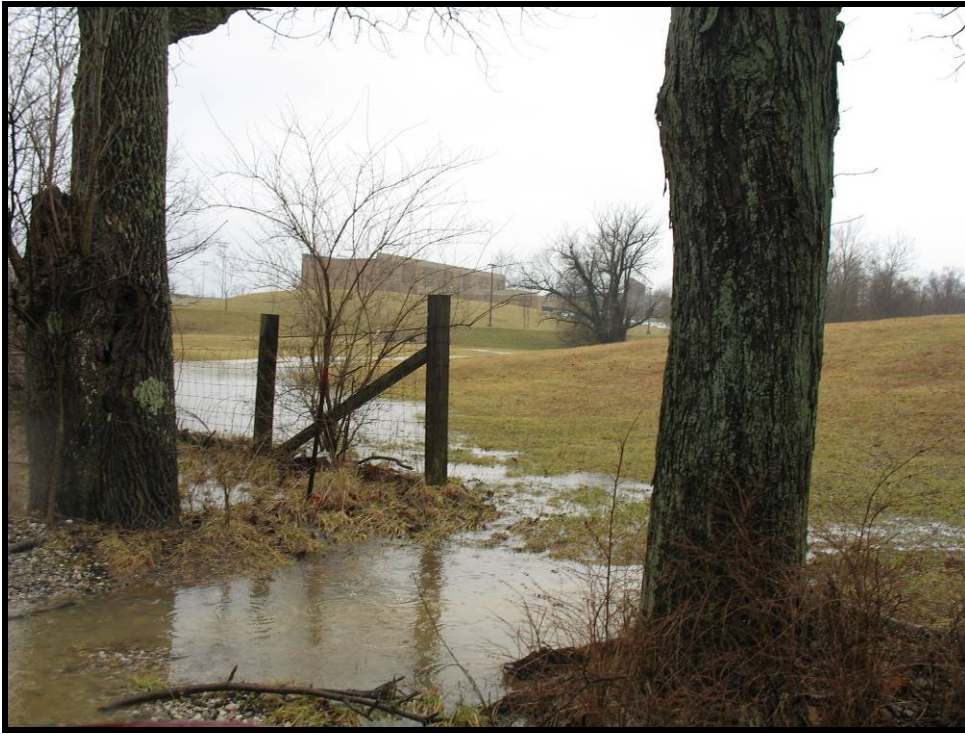
Figure 15. Runoff from the IU Motor Pool and Auxiliary Library Facility contribute to standing water along Range Road.

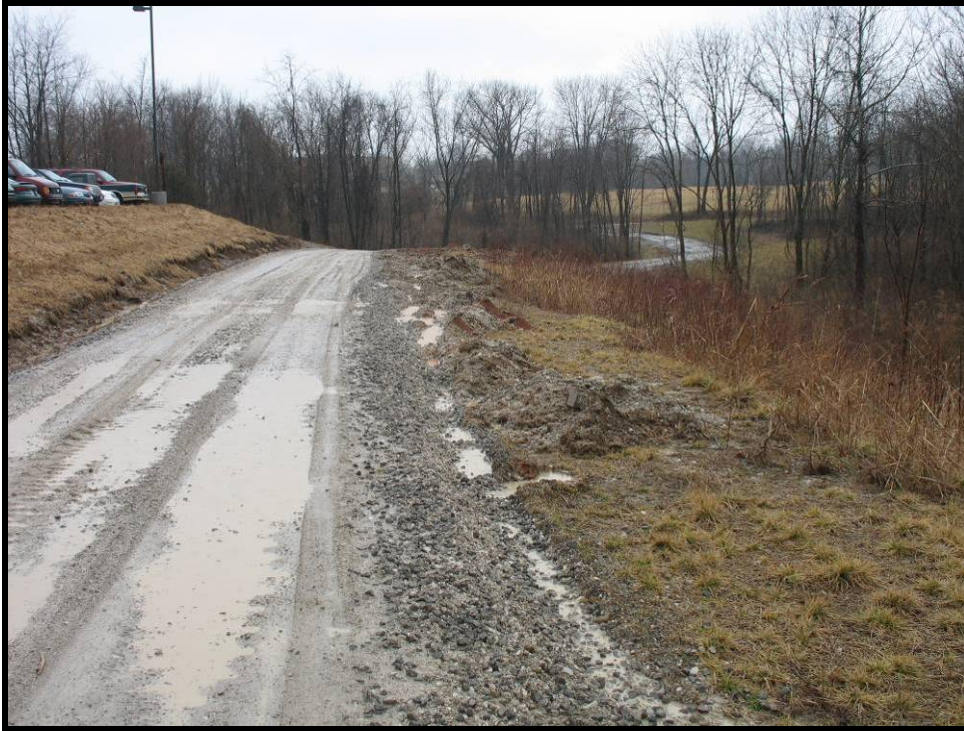
Figure 16. A gravel road to the storage area at the new IU Physical Plant building is unstable and erodes into Griffy Creek.

In order to prevent erosion, a stable vegetation cover should be reestablished following disturbances associated with new construction. Without a stable cover, precipitation and runoff cause soil erosion. Figures 16 to 18 illustrate examples of current development within the Griffy Lake watershed and the development's potential impact to Griffy Lake.

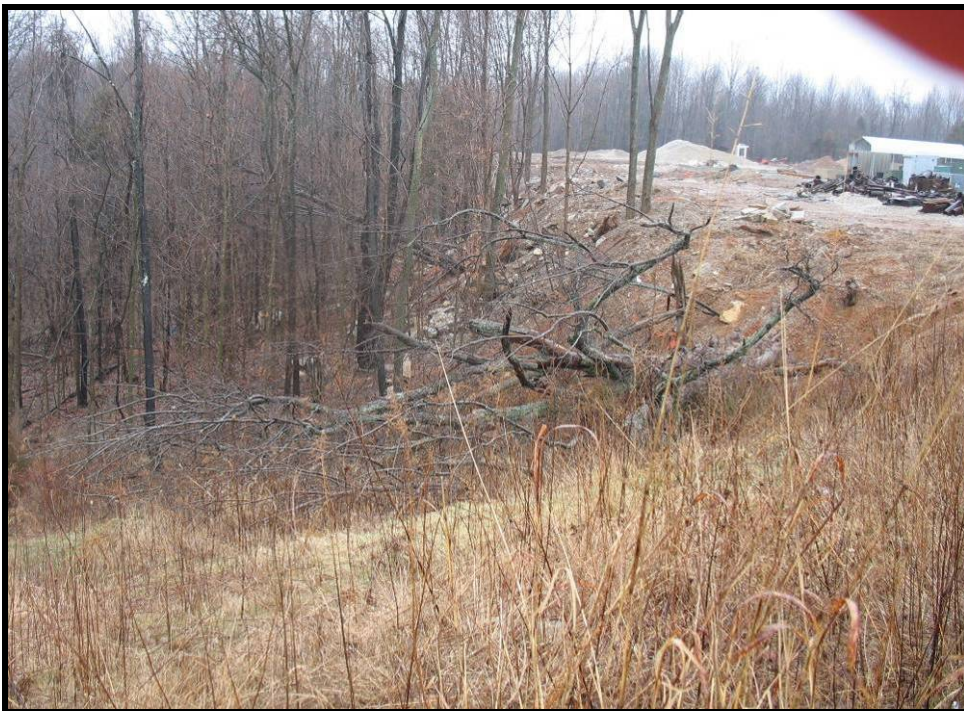
Figure 17. Equipment storage area leveled with fill dirt left a steep, unprotected embankment that erodes into Griffy Creek.

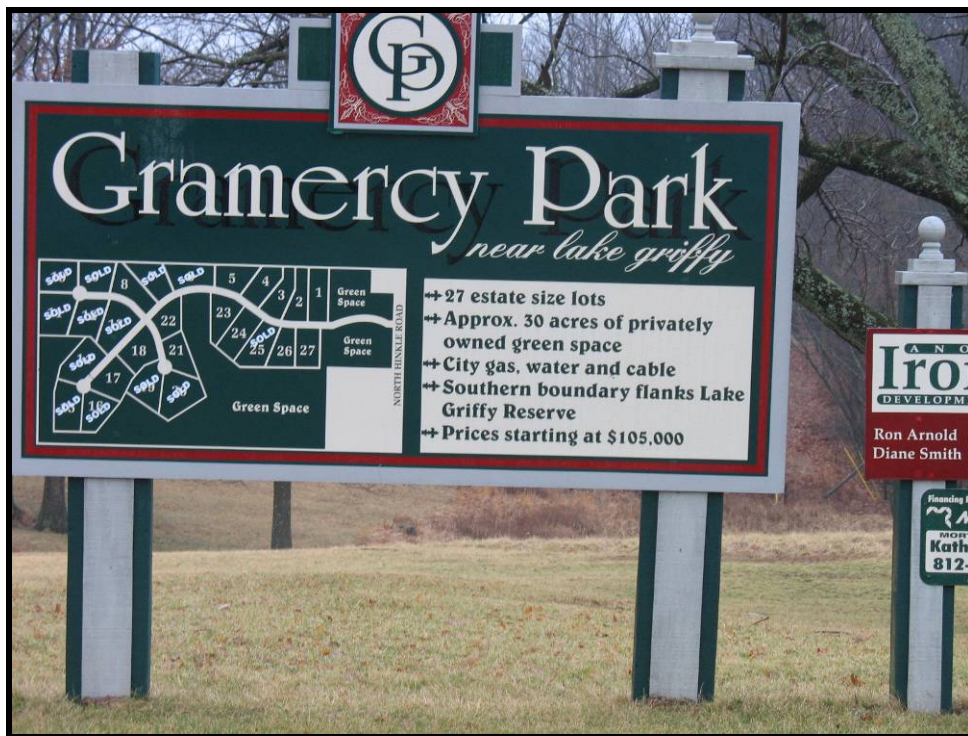
Figure 18. The new development at Grammercy Park sits on the edge of the Griffy Lake watershed. Such developments have the potential to increase water runoff, sediment loading, and nutrient loading.

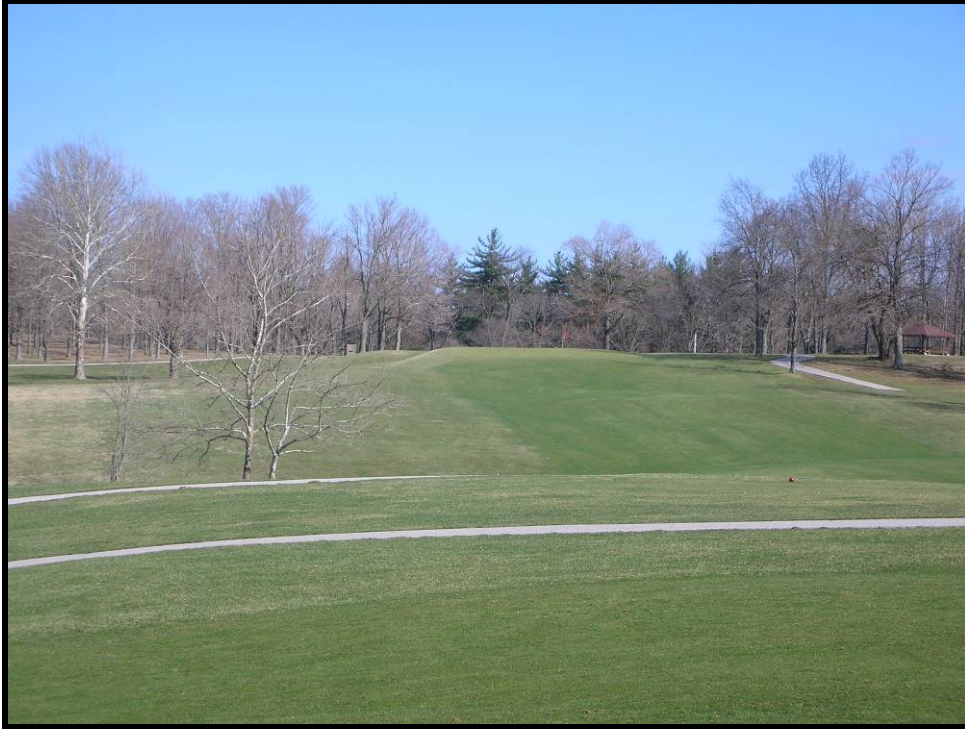
Figure 19. The IU Golf Course lies within the South Fork Griffy Creek watershed.

Recreational facilities located within the watershed also may contribute contaminants to Griffy Lake. For example, the Indiana University Golf Course (Figure 19) lies within the South Fork Griffy Creek watershed. Erosion along ravines and streams adjacent to the golf course is visually apparent with on-going monitoring of water flow from these streams to the South Fork Griffy Creek being conducted by IURTP. Fertilizers and pesticides used at the golf course have the potential to drain directly into Griffy Creek and indirectly through University Lake. University Lake (Figure 20) is extremely eutrophic and could be a source of nuisance aquatic plants of the type being managed within Griffy Lake. At another location, the equestrian facility of Devonshire has an unprotected horse manure storage pile located on the edge of Griffy Creek (Figure 21) providing a source of nutrients, sediment, and pathogens to Griffy Lake.

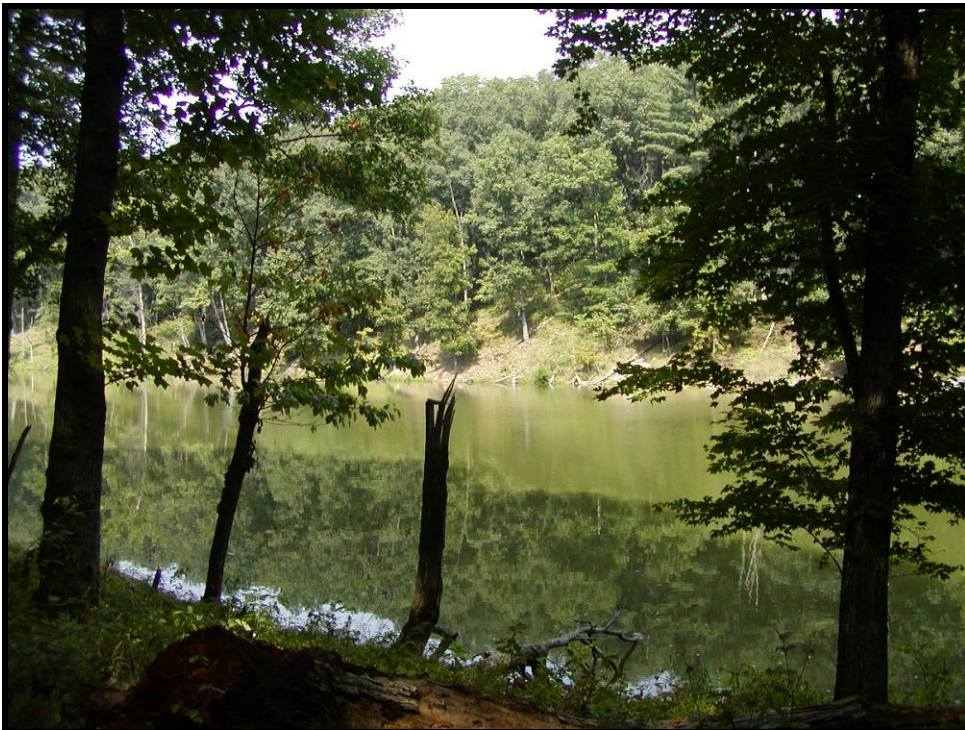
Figure 20. University Lake is a hypereutrophic reservoir that receives drainage from the IU Golf Course.

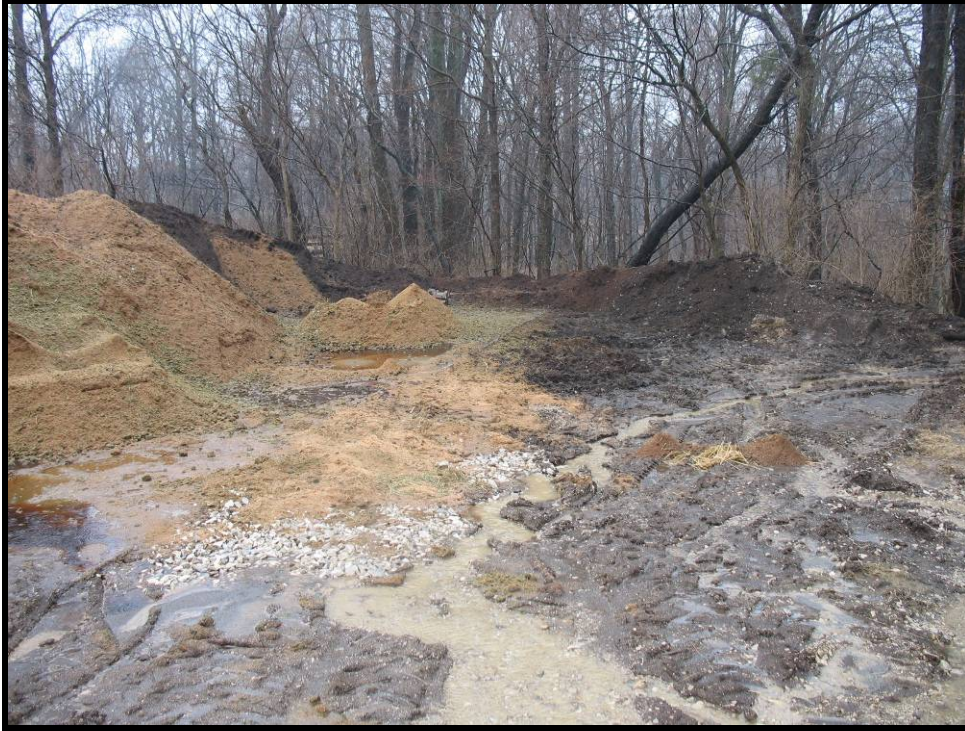
Figure 21. The unprotected horse manure pile at the Devonshire equestrian facility.

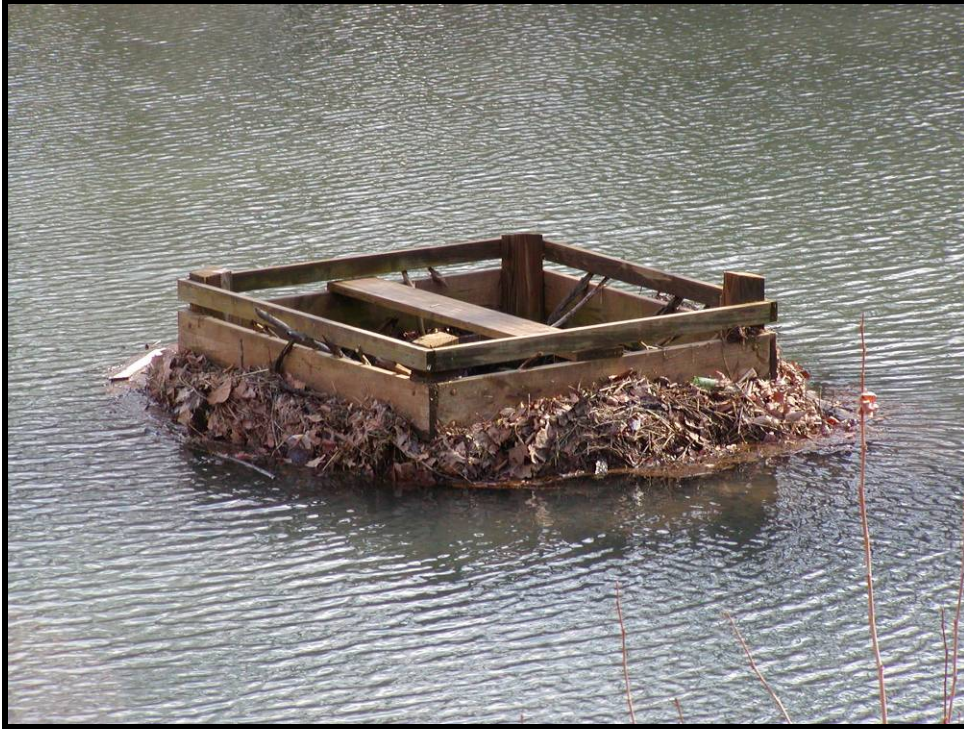
Figure 22. Clogged water control structure in the Tamarron retention basin.

Retention ponds are required in many instances to retain sediments, water, and pollutants generated during home construction within subdivisions. While these can be a benefit to clean water, they must be maintained. The outlet of the retention pond at Tamarron is clogged (Figure 22) creating substantial erosion at and below its spillway (Figure 23). The eroded sediment flows directly into the South Fork Griffy Creek and travels but a short distance to Griffy Creek.

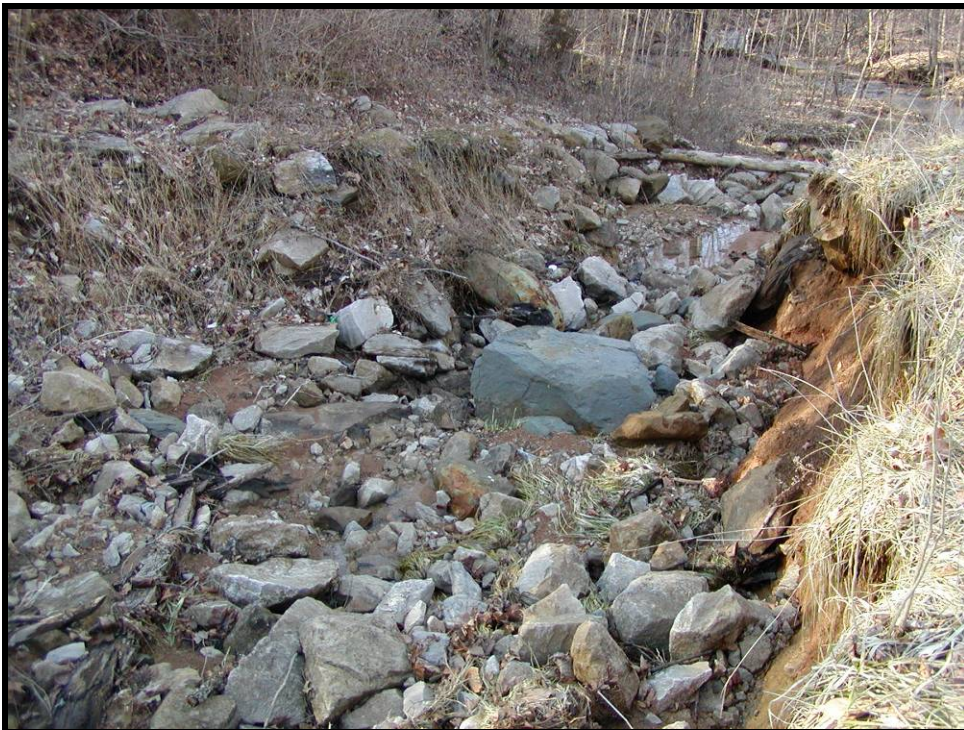
Figure 23. Eroded Tamarron retention pond outlet.

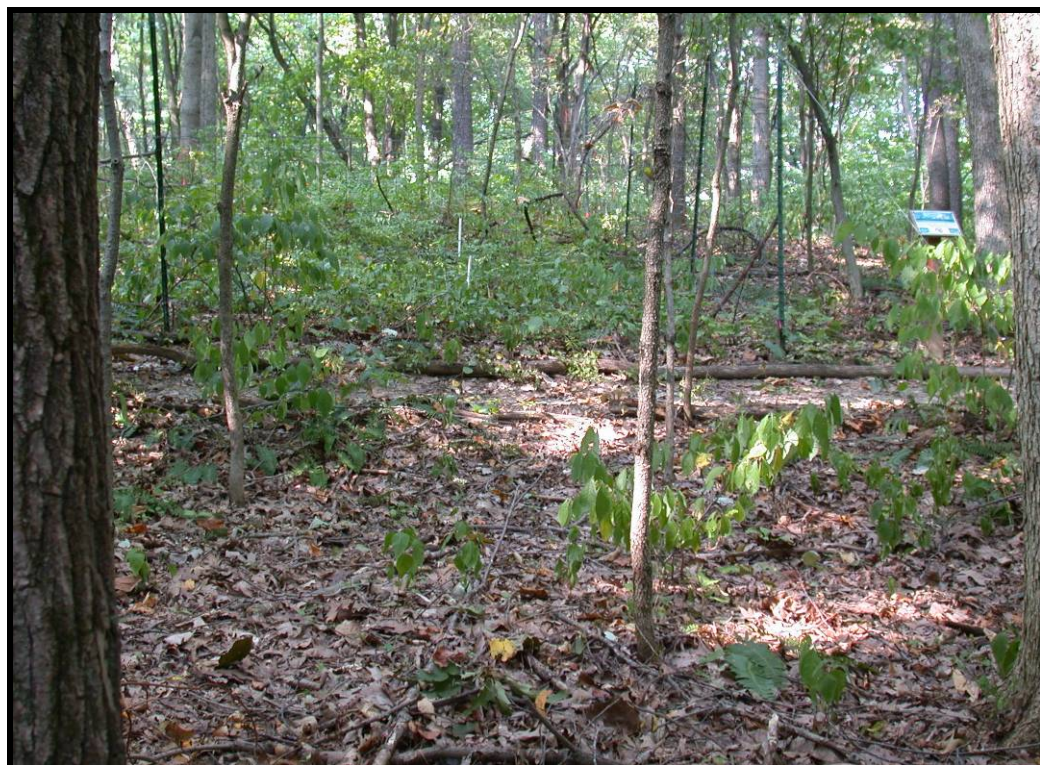
Figure 25. Deer heavily browsed the understory in the foreground in contrast to the exclosure in the background. Source: Angie Shelton.

The large deer population is stripping vegetation in the forest understory. This has destroyed plant and animal diversity in the most heavily browsed areas. These heavily browsed areas also provide opportunities for invasive species to become established. Experiments with exclosures visually show the effects of deer browse (Figure 25).
